Washington State Department of Ecology Hazardous Waste and Toxics Reduction Program

RCRA Site ID: WAH000050091	Facility Name: Treoil Industries	Date: 5/27 and 5/14, 2015
Generator Status:	Facility Address: 4242 Aldergrove Road, Ferndale

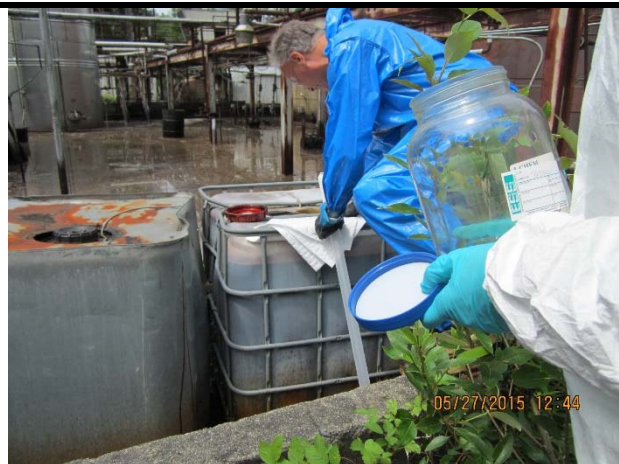
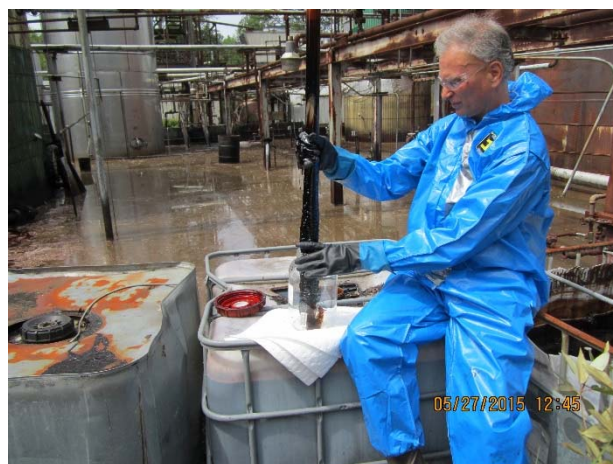
“Atul described the contents of this as tall oil in various fractions (heavier, thicker part at bottom, lighter near top). He and I agreed that the contents of this tote would be similar to other tall oil around the site (color and odor same as other tall oil I’ve been shown many times). Atul felt that this tall oil may have come from skimming the surface of the containment area, but he was not certain.”

We sampled the entire profile of this container.”

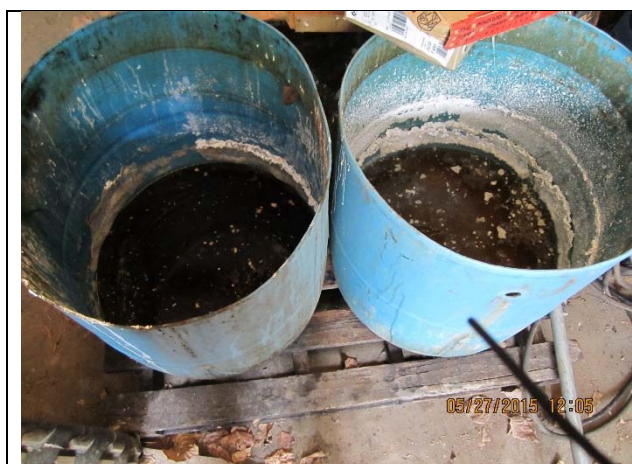
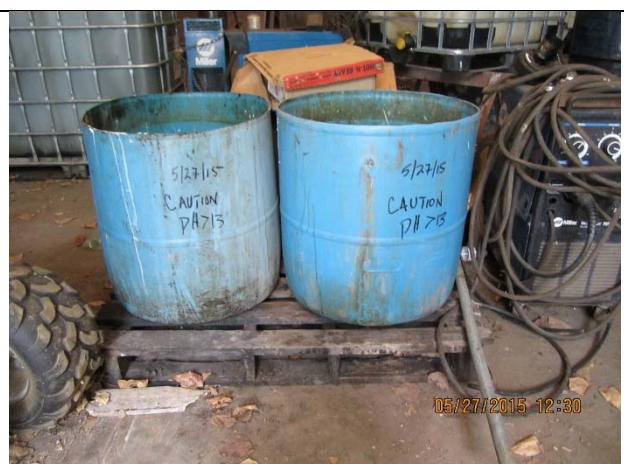
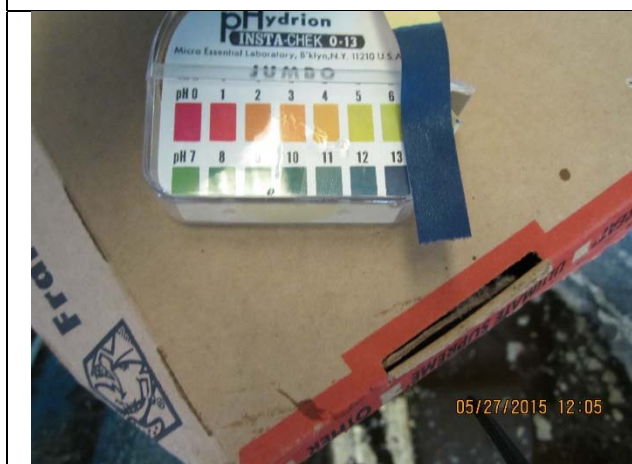
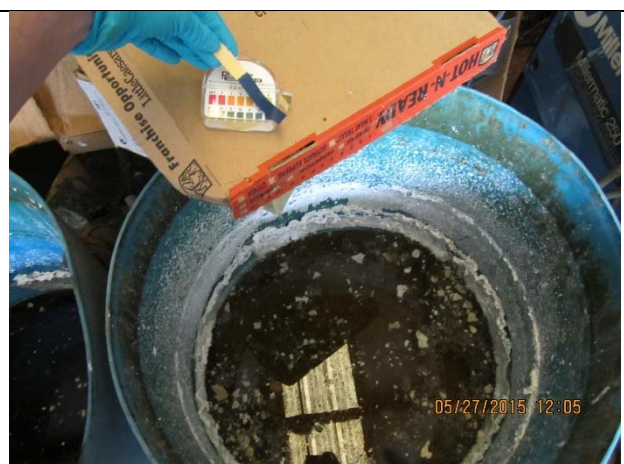
“While sampling today we discovered two open drums of something with white crystals forming along the walls of the drums. I checked the pH of the liquid, and it was over 13. I wrote “caution” on the drums. I just wanted to alert you to this. I don’t want anyone to touch the liquid or trip over it and injure themselves.”

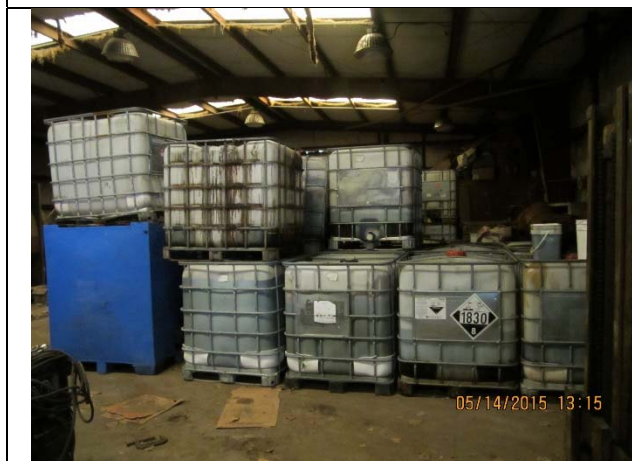
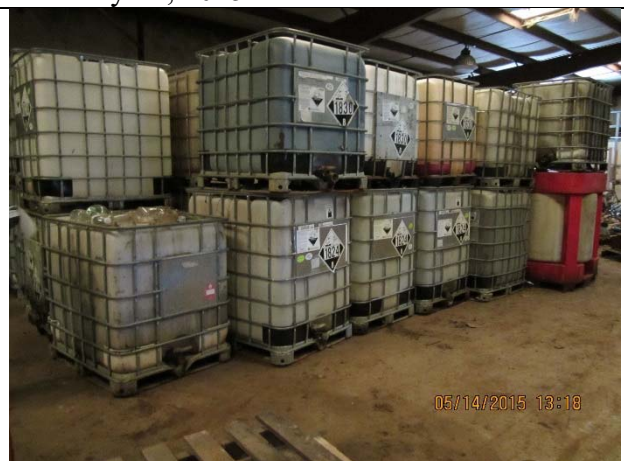
The totes shown below were moved under cover as of May 14, 2015.
